# Delivery Driver Crushed by Granite Slab— Kentucky

REPORT#: 22KY00601

## Fatality Assessment and Control Evaluation (FACE) Program

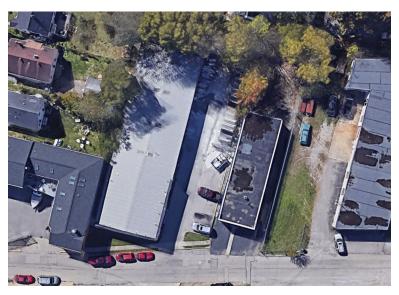
Photo 1. Parking Lot (Property of KYFACE Program)

The merchant's facility consisted of a retail showroom, offices, indoor workshop/production area, outdoor storage area, and parking lot. The incident occurred in the merchant's parking lot (Photo 1 and Photo 2). The parking lot provided a limited but sufficient amount of clearance for trucks to park for offloading. Although the parking lot was topped with asphalt, it was unevenly graded in some areas. Terrain is not considered to have been a factor in the incident.
